Special Report, 77-39

6
TEMPORARY PROTECTION OF
WINTERTIME BUILDING CONSTRUCTION

Fairbanks, Alaska, 1976-77.

CORPS OF ENGINEERS, U.S. ARMY
COLD REGIONS RESEARCH AND ENGINEERING LABORATORY
HANOVER, NEW HAMPSHIRE

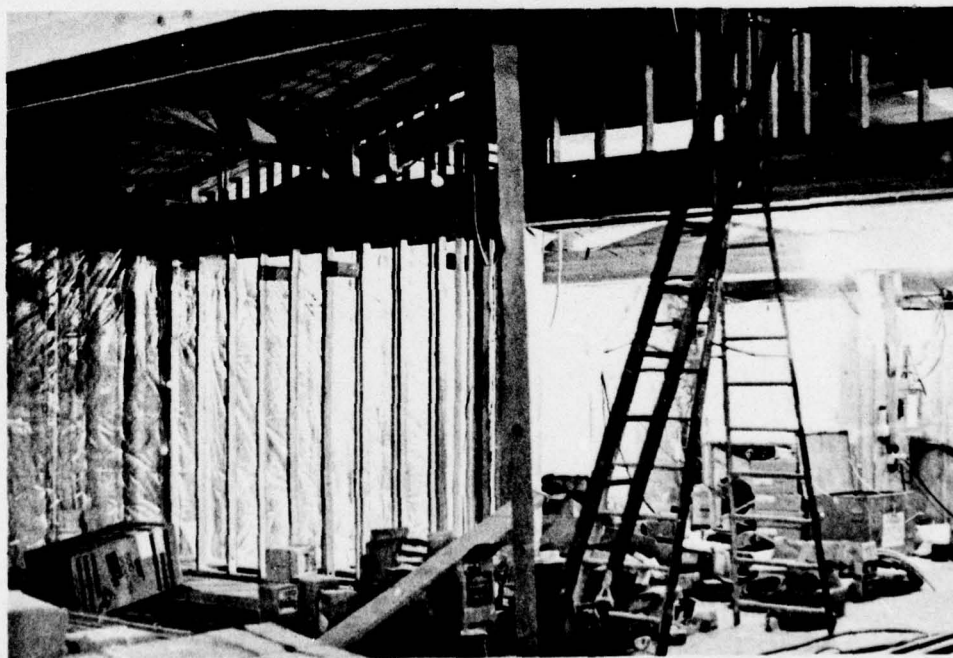
46. Interior of Plywood Supply project. December 30, 1976. -7°F.
